# Manhole Inspection Summary

Manhole # S01EE2033MH

**Location** Address: **6501 WESTERN RUN DR** Cross Street: **BANCROFT RD**

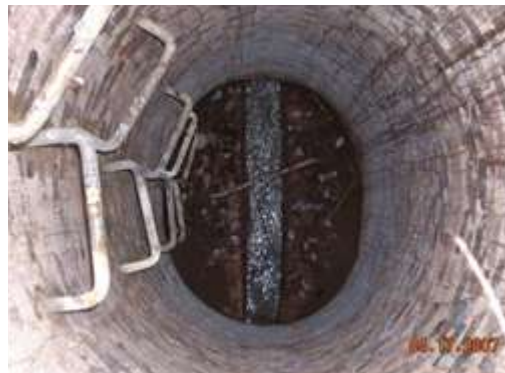
Top View

**Bench** ☒ Exists Material: **Brick** ☐ Parged ☒ **Debris** (not Condition related)  
Condition: ☒ Sound ☐ Cracked ☐ Root Intrusion ☐ Deteriorated ☐ Leaks ☐ Debris

**Surcharge** ☒ **Evidence Of Surcharge** Depth: **1** (ft.) ☐ Active Surcharge Present

Evidence of surcharge - Bench debris.

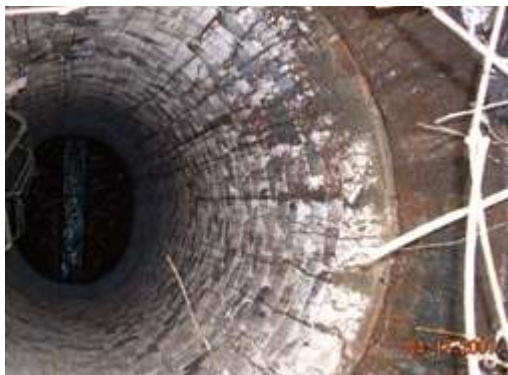
Defect

**Frame** Offset: **0** (in.) Condition: ☐ Sound ☐ Cracked ☒ **Leaks**

**Chimney / Frame Adjustment** ☒ Exists Material: **Brick** ☐ Parged Height: **6** (in.)  
Condition: ☒ Sound ☐ Cracked ☐ Root Intrusion ☐ Loose Brick ☐ Deteriorated  
Infiltration: ☐ None ☒ **Joint** ☐ Cracks ☒ **Mortar** ☐ Roots ☐ Wall

Frame leaks. Adjustment infiltration.

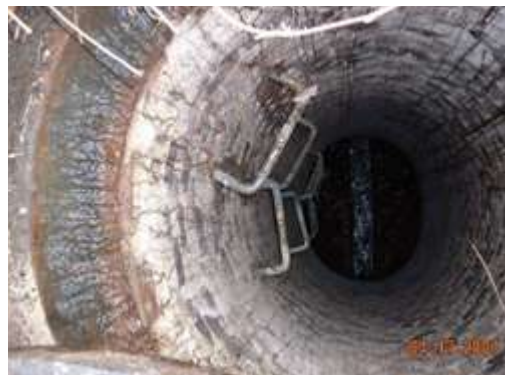
Defect

Frame leaks. Adjustment infiltration - other side.

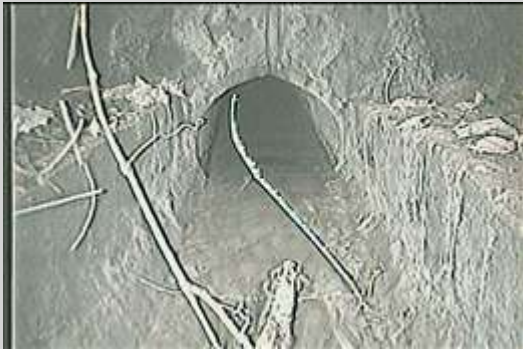
### 8 in. Circular Gravity Sewer Pipe Out @ 12 O'Clock

Comments **Revisited by CH, JJ on 04/17/07. The O12 pipe picture shows Channel debris.**

Deposits: ☐ None ☐ Mud ☐ Sludge ☐ Debris ☒ **Grease**

Silt Depth: **0** (in.) Deposits Extent: **Light**

Infiltration: **Evidence** Pipe Seal Cond: **Unknown**

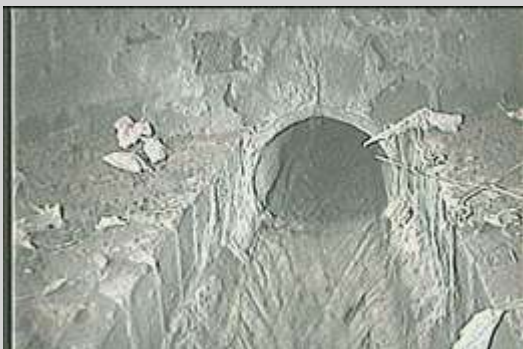
### 8 in. Circular Gravity Sewer Pipe In @ 6 O'Clock

Deposits: ☐ None ☐ Mud ☐ Sludge ☐ Debris ☒ **Grease**

Silt Depth: **0** (in.) Deposits Extent: **Light**

Infiltration: **Evidence** Pipe Seal Cond: **Unknown**
